CASE STUDY ON GEOLOGICAL HAZARD IN KARST AREAS

**The Malaysia-Thailand Border Joint Geological Survey Committee
(MT-JGSC)
2022**

**CASE STUDY 1: SINKHOLES GEOLOGICAL HAZARD IN KINTA VALLEY,
PERAK, MALASIA**

**CASE STUDY 2: ROCK FAILURE ASSESSMENT ON PALEO-COLLAPSE IN
CASE THE PRASAT HIN PAN YOD TOURIST SITE, SATUN
GEOPARK, THAILAND**

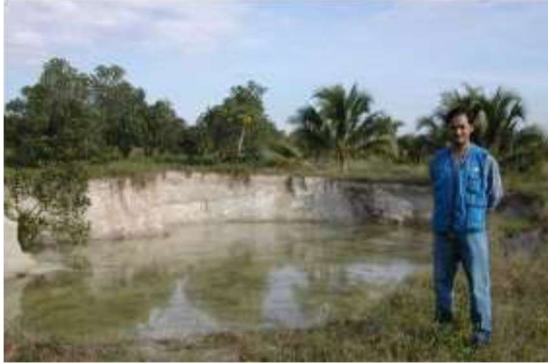
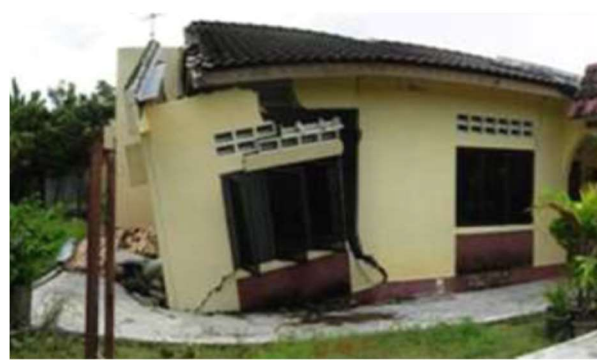
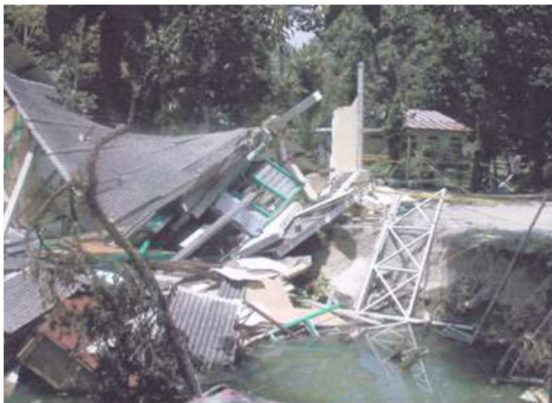
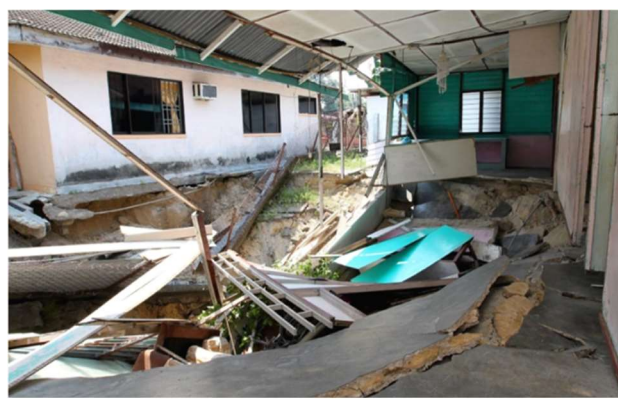
Figure 4.3 Sinkhole occurrence in various areas in Kinta Valley, Perak. Explanation (A) sinkhole occurrence in Kg. Kuboi, Gopeng after Aceh earthquake with a diameter of depression around 50 m, (B) major damage of the house caused by the sinkhole on 26 Feb 2008, (C) collapsed house in Kuala Dipang, Kampar with a diameter of depression around 25 m in 2008, (D) several houses damaged by the sinkhole with 8 m diameter of depression in Lahat, Perak.

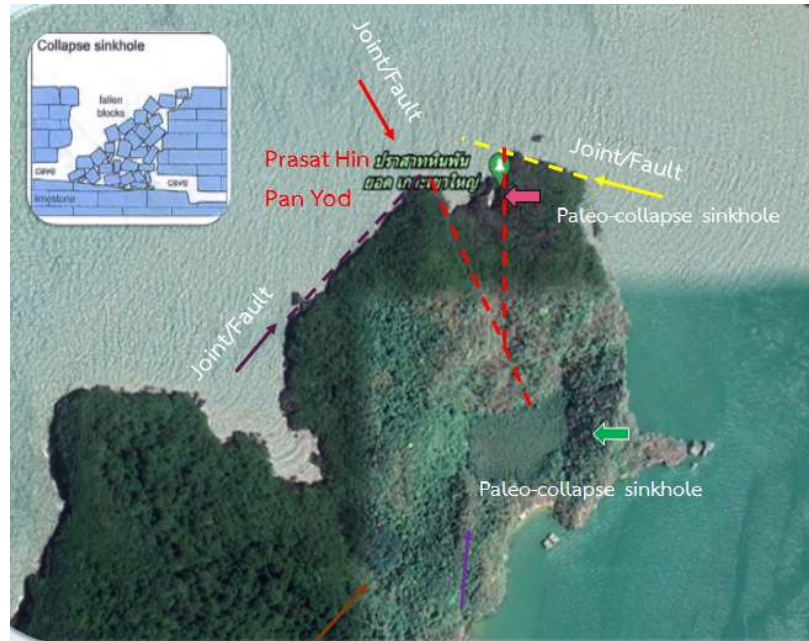
Figure 4.5 Prasat Hin Pan Yod showing oval shaped collapse sinkhole that occurred next to an older rectangular shape (Blue arrow)

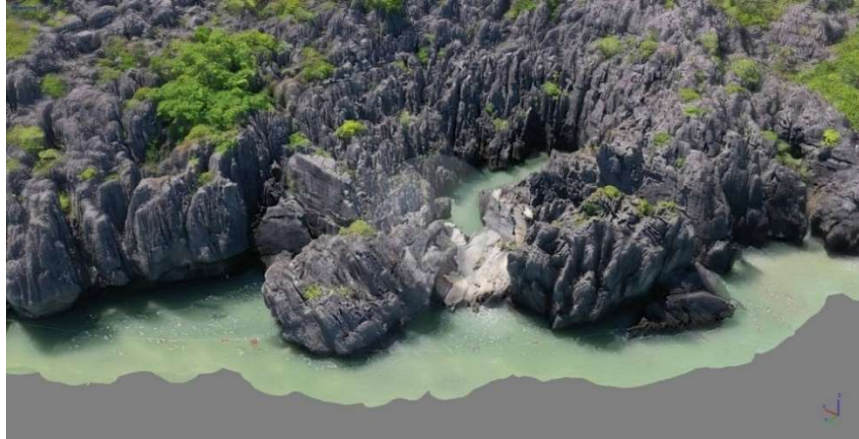
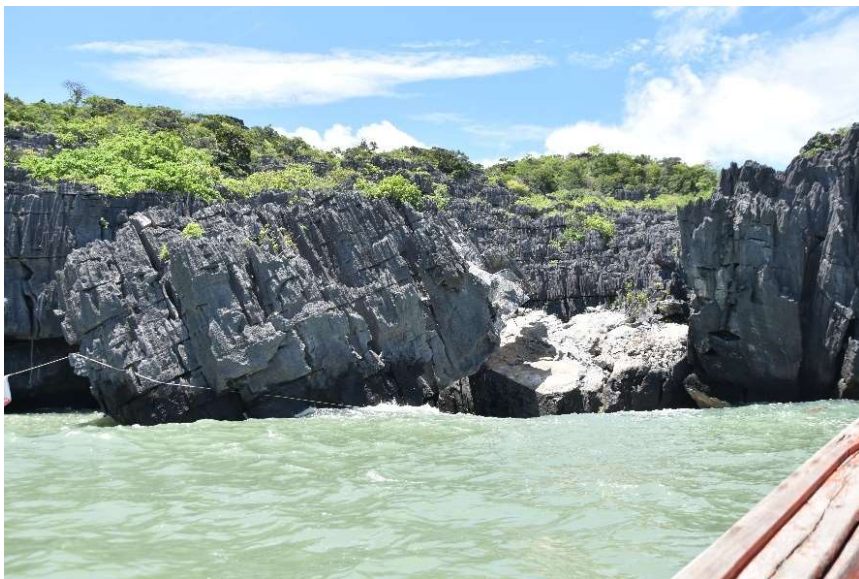
The latest rockslide big event on February 20, 2021, occurred in the north part of Prasat Hin Pan Yod chamber, Koh Khao Yai Island as shown in Figure 4.6. The area is in an administrative area in Satun province.

Figure 4.6 The latest rockslide big event happened on February 20, 2021

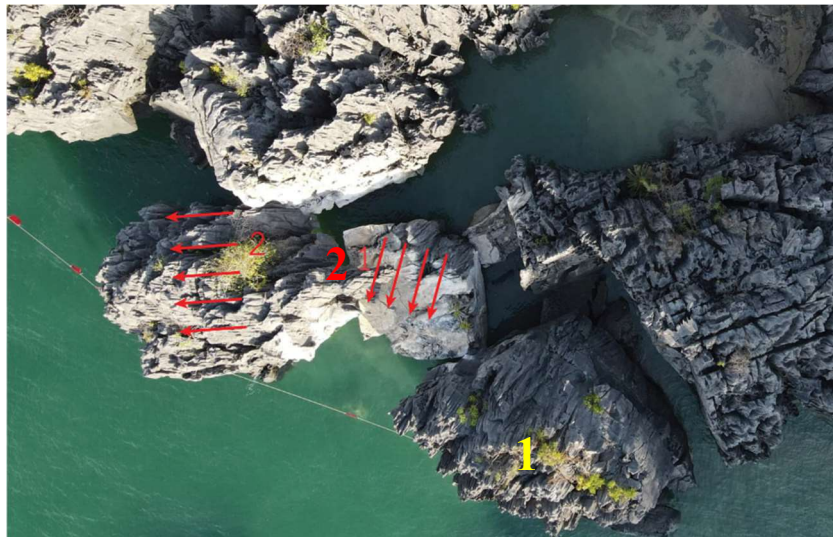
Based on the orthophotos visual interpretation, geohazards in the Prasat Hin Pan Yod area have ever occurred at least 2 times: prior to the event on February 23, 2021, there was a precedent topple block sitting nearby the latest a rockslide. A huge block of limestone was broken along a major joint/fault and fallen to sea by a toppling failure mechanism as depicted in Figure 4.7. Rock fall and rockslide in the Prasat Hin Pan Yod will have happened in the near future.

Figure 4.7 The older event occurred by toppling failure (1) and the latest caused by planar failure (2)

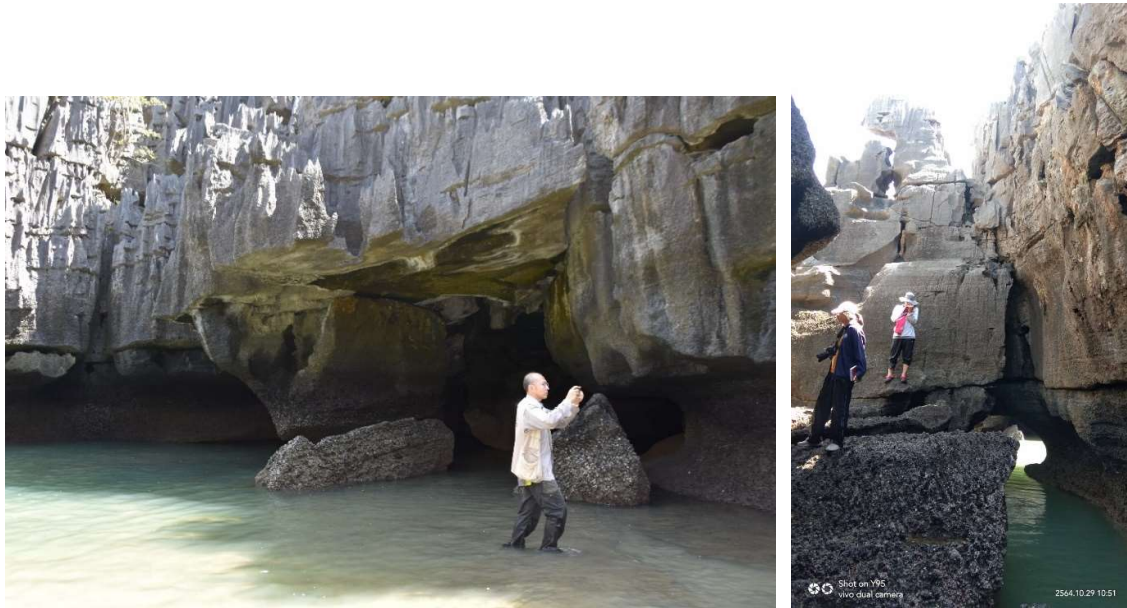
Station 4A had SMR value of 23-74, which is classified as bad to good as shown in Figure 6.12. The five intersects of joint sets was classified as bad class and the details of SMR assessment was shown in Table 6.4 and Table 6.5. The intersection of joint sets plunge to west and southwest that shows potential wedge failure of rock fall hazard type as shown in Table 6.6. Tourist may be slightly affected by small piece of rock wedge that pending at high place. Fortunately, distance passing station 4A and getting through is quite short (not over 3 meters).

Figure 6.9 station 2A and station 4A
