CASE STUDY ON GEOLOGICAL HAZARD IN KARST AREAS

**The Malaysia-Thailand Border Joint Geological Survey Committee
(MT-JGSC)
2022**

**CASE STUDY 1: SINKHOLES GEOLOGICAL HAZARD IN KINTA VALLEY,
PERAK, MALASIA**

**CASE STUDY 2: ROCK FAILURE ASSESSMENT ON PALEO-COLLAPSE IN
CASE THE PRASAT HIN PAN YOD TOURIST SITE, SATUN
GEOPARK, THAILAND**

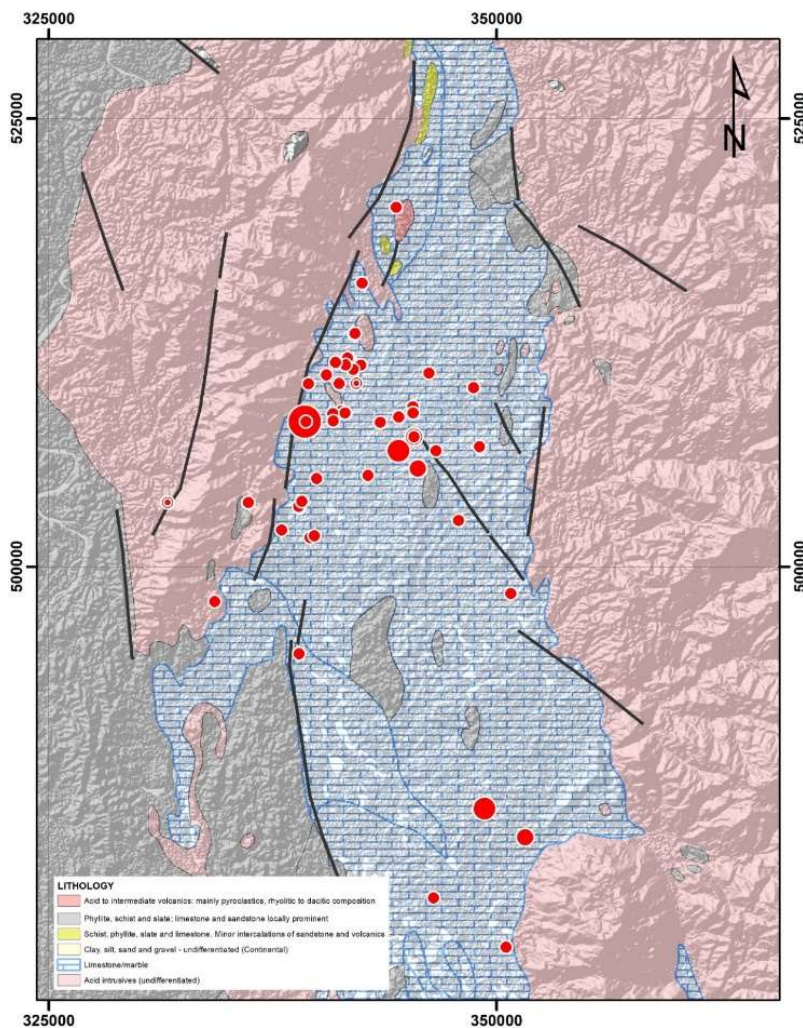
Figure 4.1 Geology of Kinta Valley, Perak (JMG, 2008) and the recorded occurrence of sinkholes

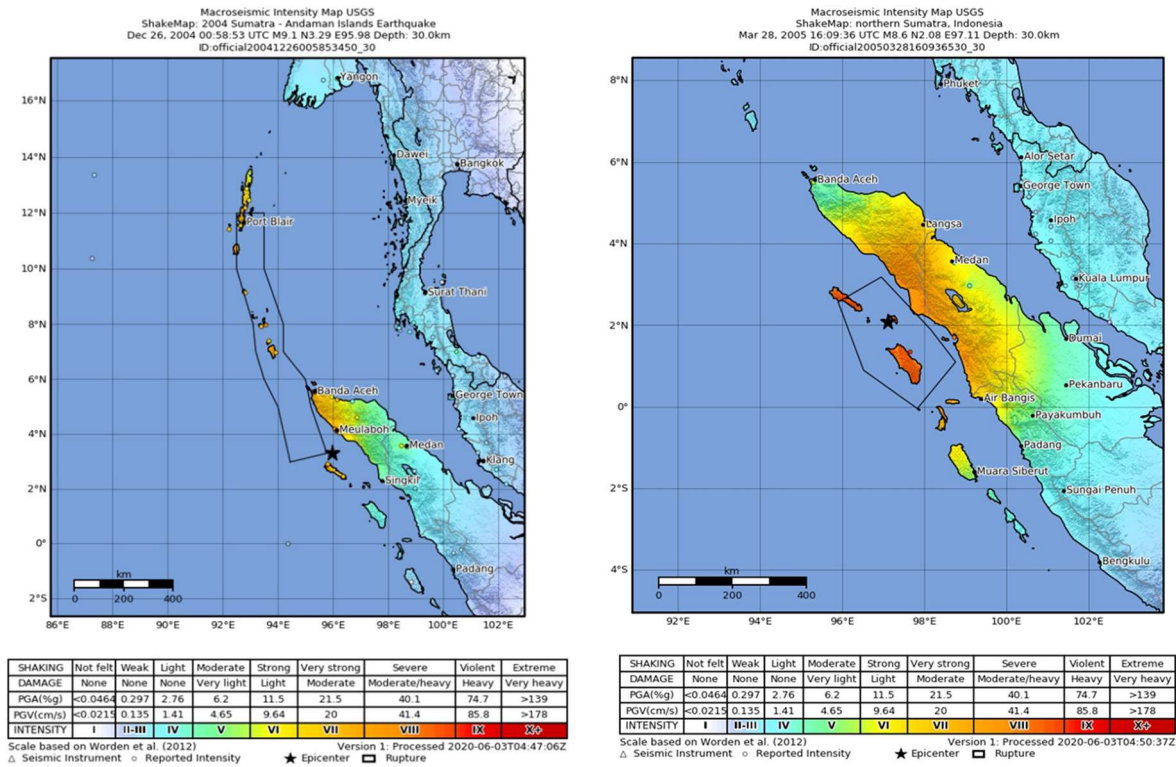
Figure 4.4 Shakemap of (A) Aceh Earthquake, and (B) Nias – Simeulue Earthquake from United States Geological Survey website (<https://www.usgs.gov/programs/earthquake-hazards/earthquakes>). Both earthquakes caused light shaking in the study area, which triggered sinkhole.

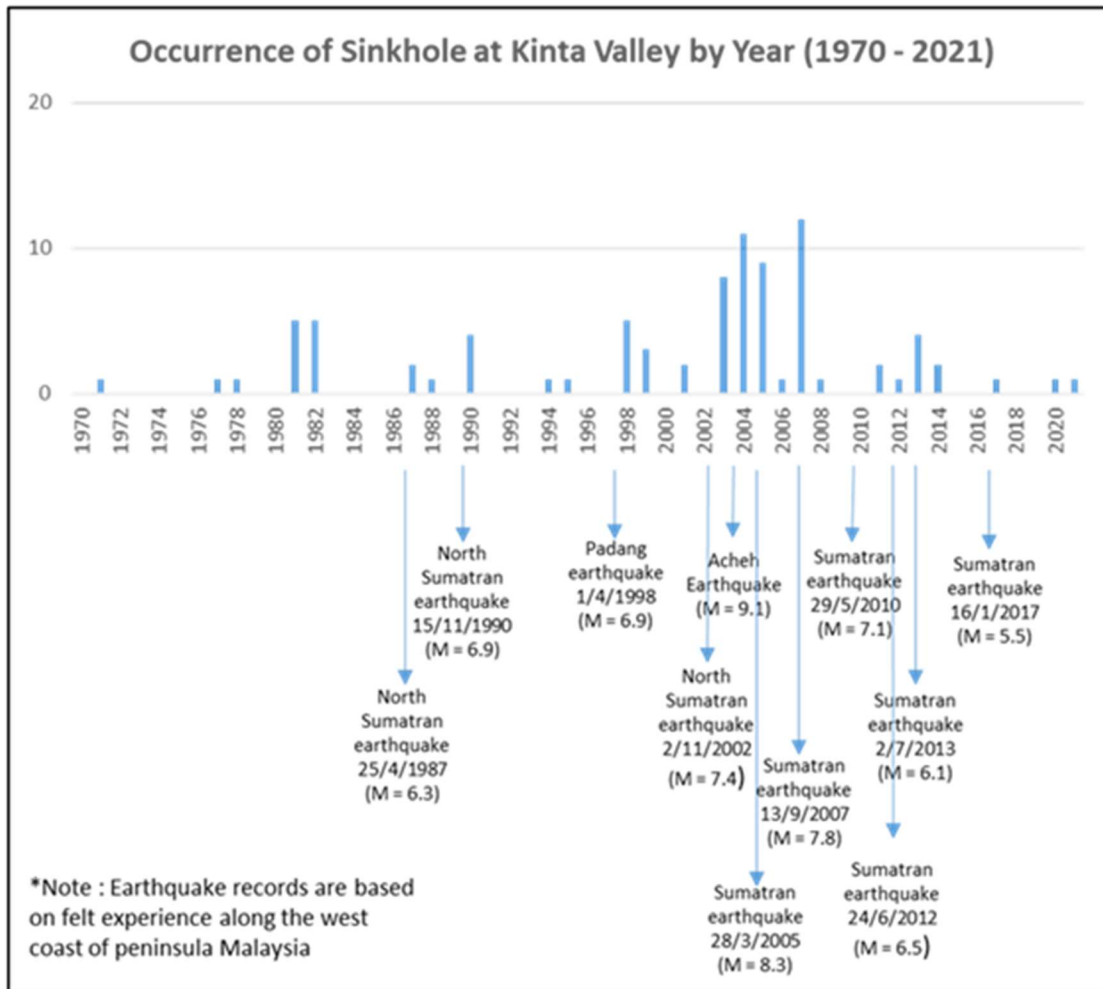
The data provided by JMG shows that the frequency of the sinkhole occurrence in the study area is increasing from 1970 until 2007 with the highest annual reported between 2003 and 2007 and after which the trend decreases (Figure 4.5). This period of high occurrence can be correlated with the tremors felt from far-field earthquake incidences that happen during the same period, such as Aceh Earthquake on 26th December 2004 (Mw = 9.1) (Figure 4.4(A)) and Laut Sinabang- Silarut Earthquake on 2nd November 2002 (Mw = 7.4), Nias-Simeulue Earthquake on 28th March 2005 (Mw = 8.6) (Figure 4.4(B)) and West Sumatran Earthquake on 13th September 2007 (Mw = 7.8). In total, 11 incidences of tremor felt in study area has been recorded since 1984 and the same year the tremor recorded is aligned with the higher occurrence of the sinkhole, compared with the non-recorded year.

The declining frequency of sinkhole after 2007 might suggest that most of the pre-existing shallow cavities and voids in the area has been stabilized or had collapsed after the major earthquake event. The same cases of sinkhole plague occurrence after earthquake also happen worldwide, such as Petrinja Earthquake in Croatia in December 2020 (Mw = 6.2) causing 90 sinkhole appearances, mostly in Mecencani and Borojevici area (Bacic et al., 2021), and Bohol Earthquake in Philippine on 15th October 2013 (Mw=7.2) causing the 100 incidents of a sinkhole in Bohol Island Philippine (Manzano et al., 2013).

Figure 4.5 Correlation between the felt far-field earthquake event and the intensity of sinkhole occurrence in the study area.

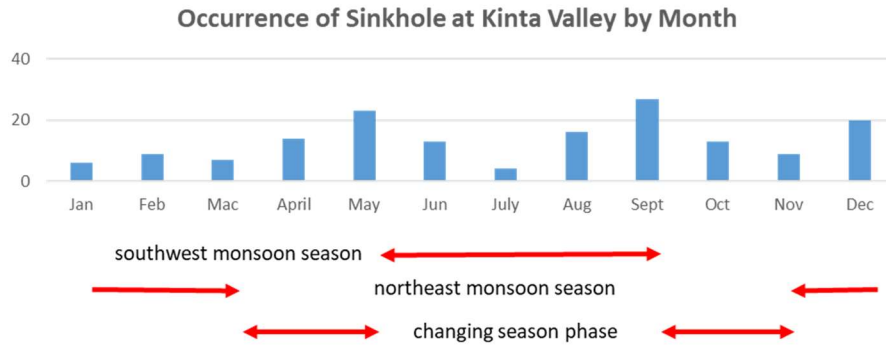
time. According to the meteorological data, the western part of Peninsular Malaysia is having a dry season (minimum monthly rainfall accumulation) during February and the wet season (maximum monthly rainfall accumulation) is recorded in October and November are separated by the transition phase (Figure 4.6). During the transition phase, downpours usually occurred locally at certain place with unexpected amount of daily accumulation, causing the rate of groundwater level fluctuations to be drastically higher compared to the other period (Figure 4.7).

Figure 4.6 Correlation between frequency of sinkhole occurrence by month and the seasonal changing phase of West Peninsular Malaysia.

The fluctuations of the groundwater level are related to the formation of cavities in the limestone bedrock whereas most cavities developed within the zone of groundwater level fluctuation (Kong, 2002). Groundwater would act as a filler for the existing cavities and caves, causing the hydrostatic pressure that withstand the loads on upper surface without collapsing. The pressure generated from the high groundwater velocity due to the rise of the groundwater level would also accelerate the erosion process of limestone bedrock and forming cavities and void's structure (Bell, 1999). When the groundwater level declined, the cavities became 'empty' and lose the hydrostatic pressure and causing it to collapse (Ahmad Khairut Tarmizi et al., 2018) and that explains the occurrence of sinkhole in study area are frequently reported during the transition of seasons.

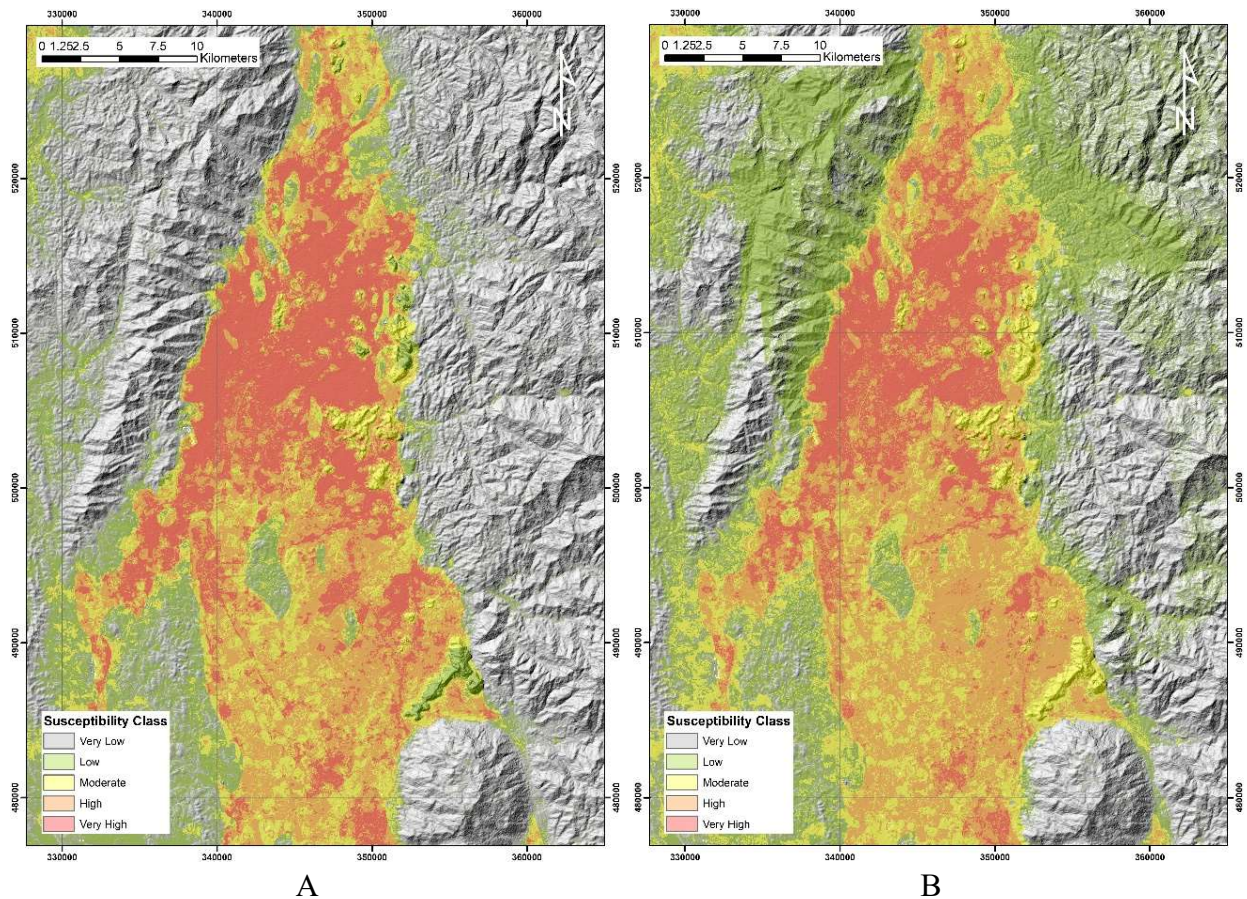
Validation assessment on both produced sinkhole susceptibility index map shows a different accuracy. For the very high classes, AHP model shows a 79.31% occurrence while for the FR Model shows 72.42% of occurrence (Table 6.4). Both maps shows that most of the Kinta Valley region are regarded to be from intermediate to very high possibilities of sinkhole occurrence.

Some exaggerated results were encountered for both maps. For instance, AHP Model shows more exaggerated classification than FR Model (Figure 6.3). The plain and low elevation terrain located in the northwest of the area show an intermediate-low class of sinkhole susceptibility, due to lithology which consists of granitic basement. This might happen due to the high prediction rate for lithology conditional factor compared to the other conditional factor, or the quality and reliability of the data itself. Hence, thorough quality check and assurance should be conducted before determining the conditional factors.

Figure 6.3 Sinkhole susceptibility map produced using (A) Frequency Ratio Method and (B) Analytical Hierarchy Process Method (AHP).

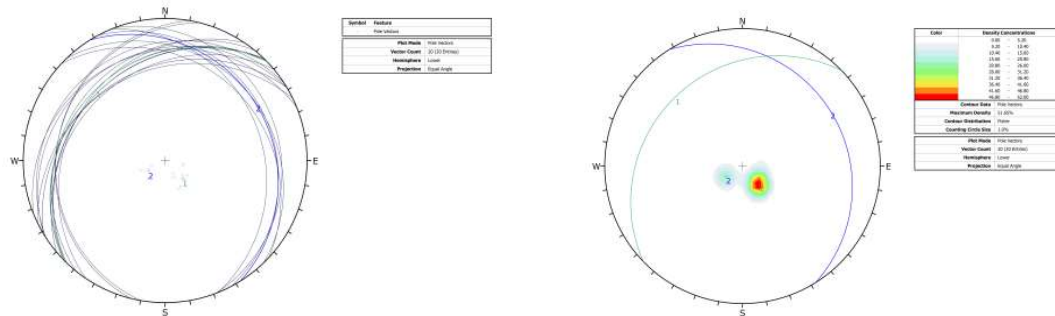
The Prasat Hin Pan Yod chamber is naturally a paleo-collapse sinkhole. Based on the sinkhole classification presented by Waltham et al., (2005), a collapse sinkhole is a roof collapse happening on unstable limestone beneath, particularly cavernous and high fracturing rock. The sinkhole originated on the hinge zone of a small asymmetry anticline whose fold axis is orientated nearly north-south (NNE-SSW) and gently plunged at 11° in a direction 014 (NNE). Limestone bedding planes have an average dip angle of 25 ° in direction 320 (NW) and dip at 15 ° in direction 035 (NE). A well-defined bimodal clustering on stereonet (Figure 4.3) shows the dominant strike directions of joint and fracture in limestone rock mass have approximately four directions. The discontinuous plans are trending nearly north (NNW-SSE to NNE-SSW), northwest-southeast (NW-SE), northeast-southwest (NE-SW), and east-west (E-W). Thinner bedded limestones generally shows narrower spacing of joints and higher fracture density compares to massive limestones. Due to the southwest monsoon climate and sea process, the erosional karstic surface is well developed on strongly fractured limestone, particularly in the upper part of its succession as shown in Figure 4.4. According to karstic landforms, the imagination of people when they look at limestone pinnacles exposed on islands it resembles castle-like features with a thousand peaks.

Figure 4.3 Limestone anticline having a fold axis orientation in nearly north-south

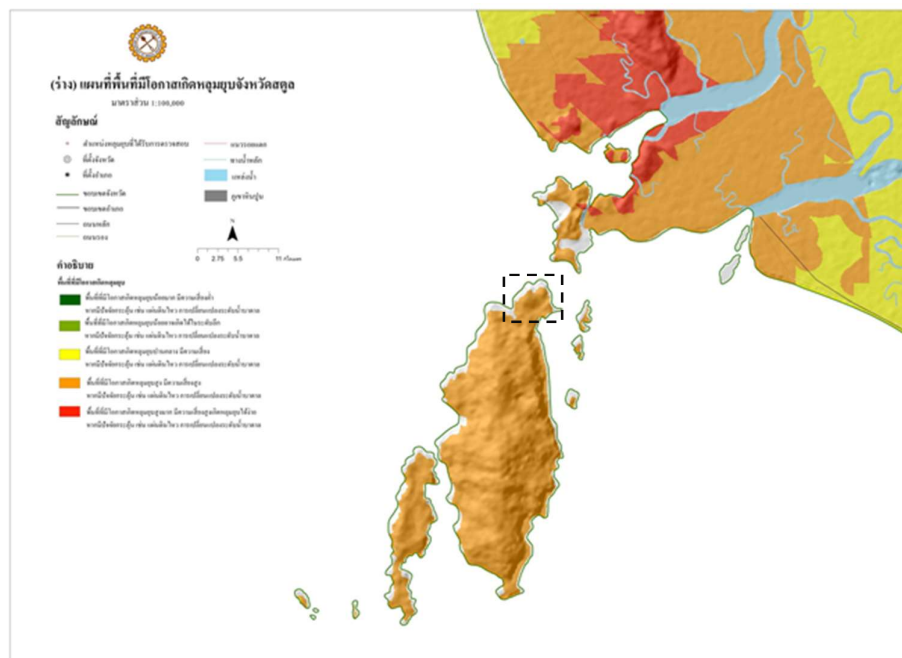
Figure 6.2 High sinkhole potential covering the Prasat Hin Pan Yod chamber (Black dash rectangular shape) and the overall area of Koh Kao Yai Islands

The first sinkhole potential map was published in 2005 by DMR, then it has been updated in 2022 by using the GIS system. The simple overlay technique of various relating factors was utilized for analysis. The five factors adopted for the improvement of sinkhole zoning have consisted of the density of lineament intersection, lineament density, distance to lineament, stream density, and distance to stream. Enhanced sinkhole potential area is classified into five levels which are very low, low, medium, high, and very high. All levels could be found on the Koh Kao Yai Islands. The grid cell resolution of result data is 30x30 meters. The high potential area is abundantly covered in the Koh Kao Yai Islands, particularly in the Prasat Hin Pan Yod sinkhole chamber (Figure 6.2). Types of the sinkholes as classified by Waltham et al., (2005) do not conduct by the DMR due to the scarcity of fundamental analysis data. However, an enhanced sinkhole potential map is still useful for limestone failure assessment in the Prasat Hin Pan Yod area.

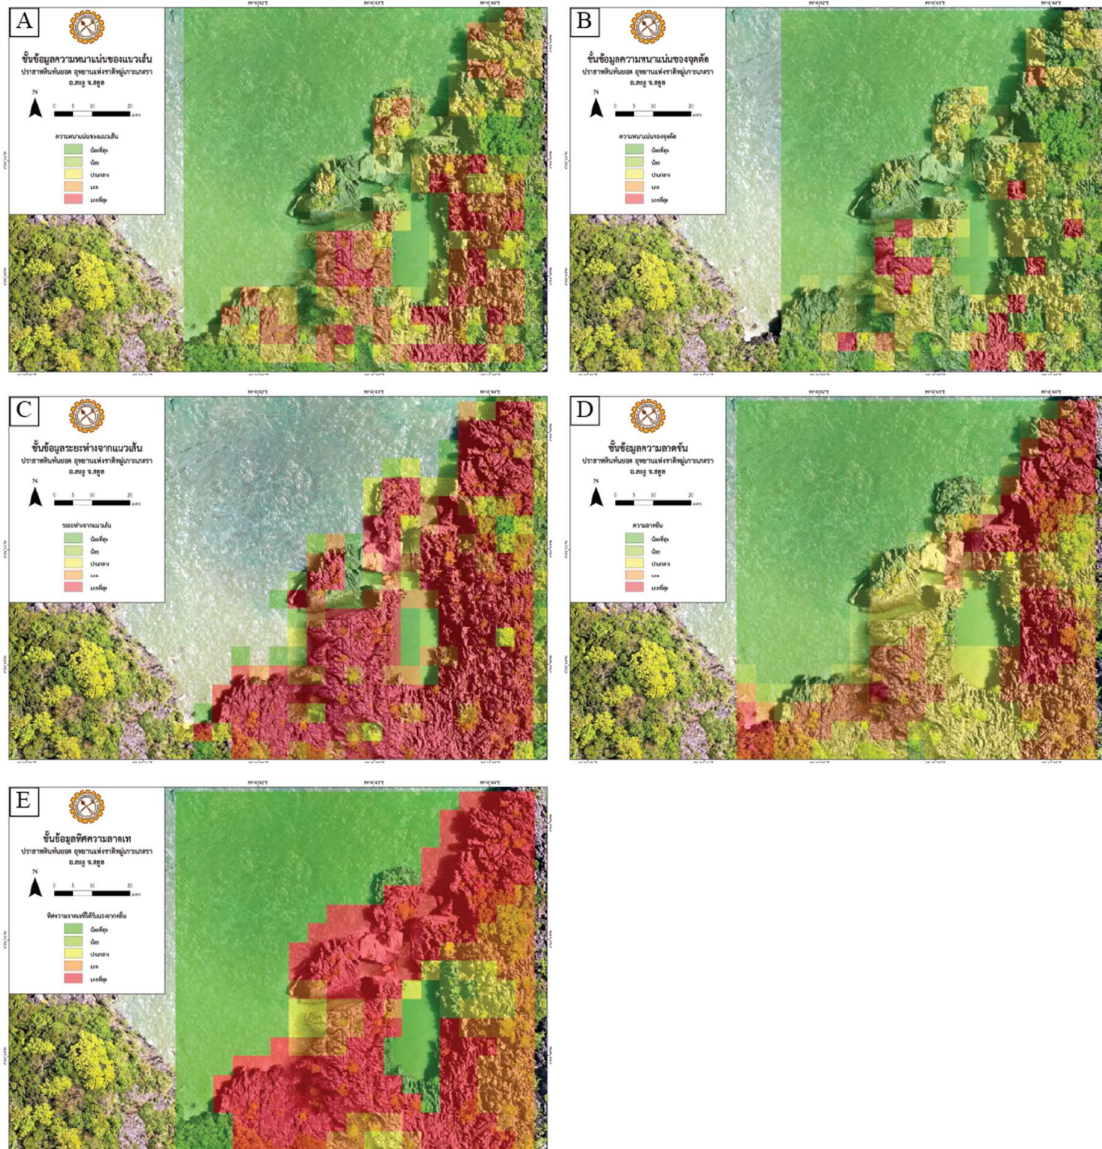
Figure 6.3 Five factors for preliminary rock fall hazard mapping using GIS; (A) density of lines, (B) density of intersection points, (C) Lineament proximity, (D) slope, and (E) aspect.

To examine the overview rock mass stability and select suitable locations for collecting field data, rock fall hazard zonation of the Prasat Hin Pan Yod chamber had mapped by using the approach of simple multi-criteria in GIS. The five basic factors were integrated to analyze and delineate rock fall hazard areas (Figure 6.3). They are consisting of density of lines (Figure

6.3A), density of intersection points (Figure 6.3B), Lineament proximity (Figure 6.3C), slope (Figure 6.3D), and aspect (Figure 6.3E).

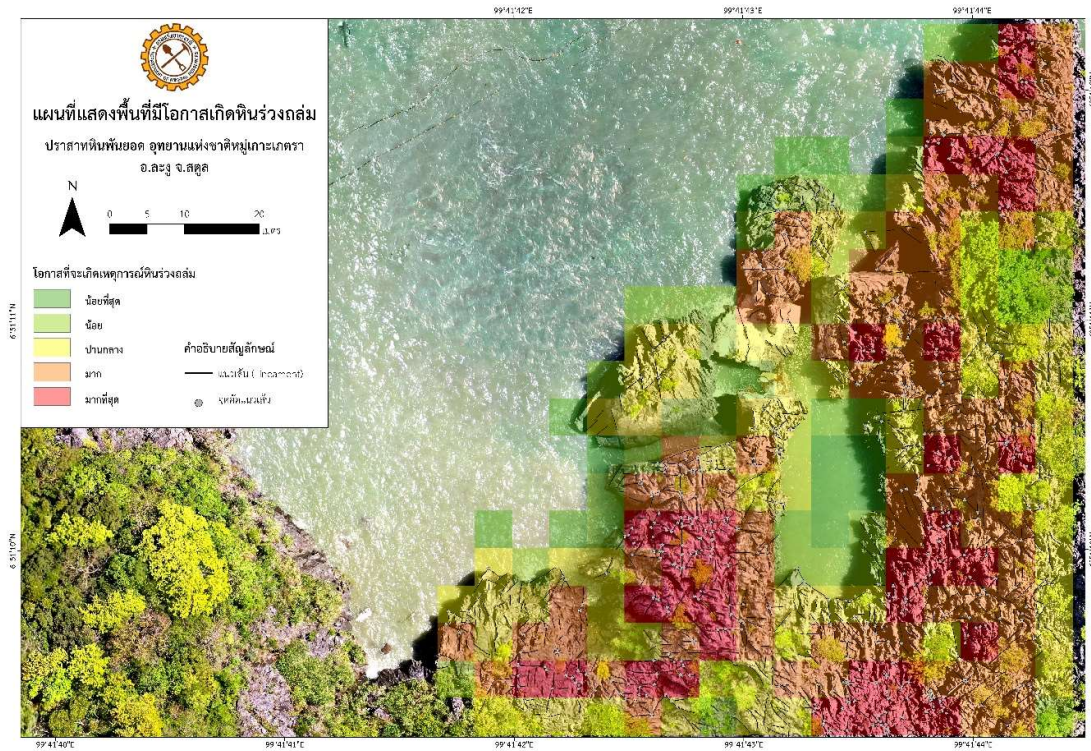
Figure 6.4 preliminary rock fall hazard map, Prasat Hin Pan Yod tourist site, Satun province

The rock fall hazard zonation (Figure 6.5) resulted in a grid cell size of 5x5 meters and was categorized into 5 classes including very low, low, moderate, high, and very high. The map shows moderate to high level hazard seems to be happening along sea cliffs and at the entrance of tourist sites as well.

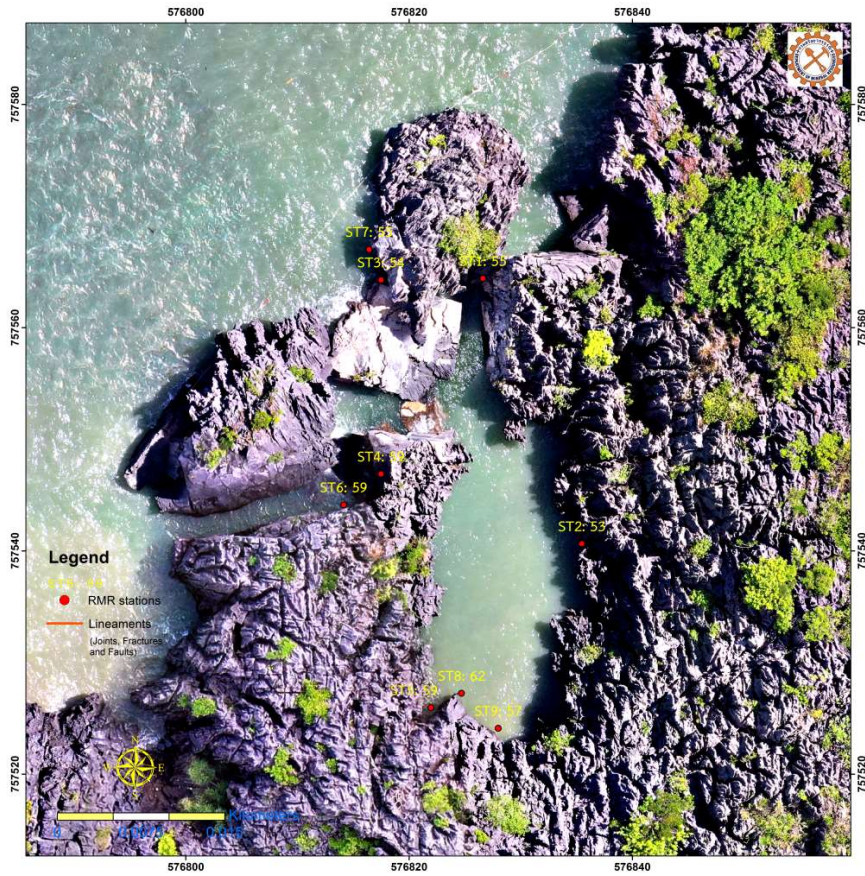
Figure 6.5 showing stations of measured Rock Mass Rating overlying on orthophoto

The RMR values can be estimated through nine locations (Figure 6.5) distributed along the rim of the sinkhole chamber, a big broken block of limestone, and the new expected entrance of the tourist site. The RMR values ranged from 53 to 62. They are detailed in Table 6.1. The result shows that the RMR of bedded limestone has a lower value than massive limestone. Thinner bedding is stratigraphically overlying on the Massive limestone, so it is hard to explore unstable rock when rock mass locates in the high places of the Prasat Hin Pan Yod area.

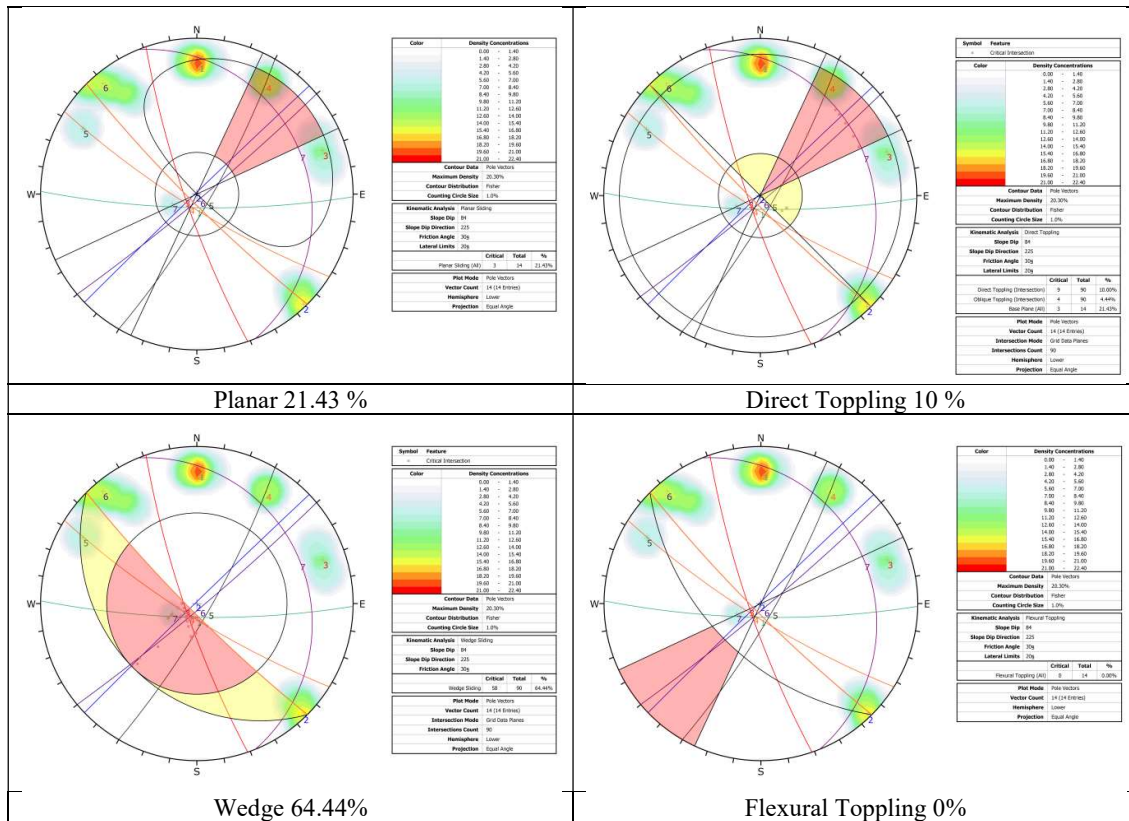
Figure 6.1 showing stereographic projection of the station 2C

The result of rock failure analysis using stereographic projection was shown in Table 6.2 and the failure model of some investigating stations were stereographically illustrated in Figure 6.6 to Figure 6.9. The study was found that the wedge failure of rock fall has more potential and happens more frequently than toppling and planar, respectively. After field checking, Wedge failure was found that it tends to be occurred small event of rock fall with small block pending in cavity and mainly caused unsafely in tourist site. For toppling failure, oblique toppling and direct toppling have the same situation as planar failure but will be happened in particularly locality. Planar failure can be occurred the lowest potential of rock fall, but big events with huge block can be happened in the recent time, for example, the Rock fall/Rock slide event of the Prasat Hin Pan Yod area in February 23, 2021.

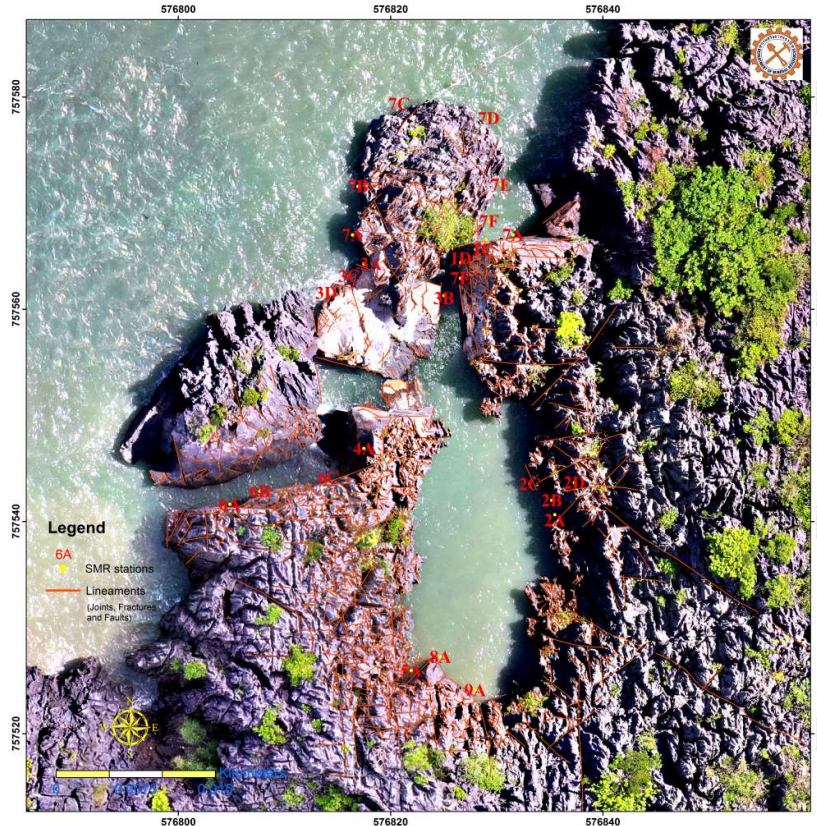
Figure 6.8 showing stations of Slope Mass Rating (SMR) assessment

3) A high eroded sea cave with clues of former rock fall and thin column supporting with high potential hazard, which representative stations was composed of 2A to 2C

4) A small beach within the Prasat Hin Pan Yod chamber that exposed whenever low tide, the representative stations were 8A and 9A

Slope Mass Rating (SMR) were calculated and classified according to Romana (1985). The SMR assessment in detail of station 2A and station 4A was partly shown in Table 6.3 and Table 6.4, respectively. The overall result of the 26 station was depicted in Table 6.5, and was shortly summarized in Table 6.6
